**TWO GUYS FROM TEXAS / PART 4**  
By Bruce Fullerton and Robert Mace

*The amazing Isetta "Belchfire 300" Heater System!*

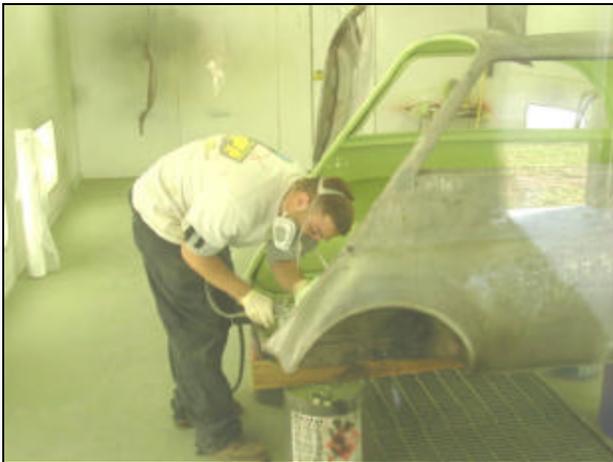
*Aaron Bowen of Classic Auto Works in Travis Peak, Texas giving Bruce's car its first squirt of Glasurit epoxy sealer. More action pix next time.*
